Manhole Inspection Summary

Manhole # S21E1_003MH

Insp Date: **5/22/08 10:31 AM**

Location Address: **2626A ridgely st**

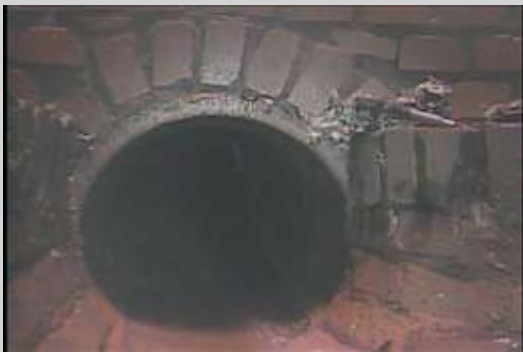
12 O'Clock Outflow

15 in. Circular Gravity Sewer
Pipe Out @ 12 O'Clock

Pipe Height: **15.6** (in.) Rod and Bar (Angled)
Pipe Material: **Clay** ☐ Pipe Lined
Invert Depth: **12.92** (ft.) Flow Characteristics: **Fast**
Deposits: ☒ None ☐ Mud ☐ Sludge ☐ Debris ☐ Grease
Silt Depth: **0** (in.) Deposits Extent:
Infiltration: **None** Pipe Seal Cond: **Sound**

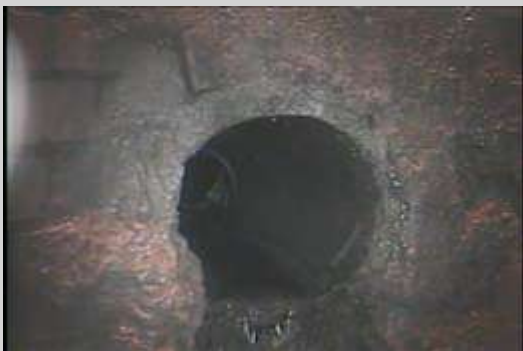
3 O'Clock Inflow

8 in. Circular Gravity Sewer
Pipe In @ 3 O'Clock

Pipe Height: **8.4** (in.) Rod and Bar (Angled)
Pipe Material: **Clay** ☐ Pipe Lined
Invert Depth: **9.90** (ft.) Flow Characteristics: **Fast**
Deposits: ☒ None ☐ Mud ☐ Sludge ☐ Debris ☐ Grease
Silt Depth: **0** (in.) Deposits Extent:
Infiltration: **None** Pipe Seal Cond: **Unknown**

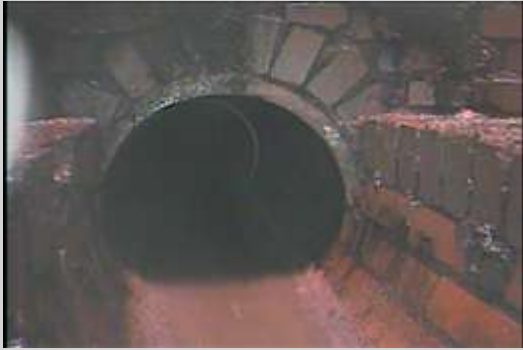
6 O'Clock Inflow

15 in. Circular Gravity Sewer
Pipe In @ 6 O'Clock

Pipe Height: **15.6** (in.) Rod and Bar (Angled)

Infiltration: **None** Pipe Seal Cond: **Sound**
